Technical Service Bulletin

91 SOS warning displayed in instrument cluster, DTC B191604 is stored in the gateway control module

91 21 32 2051664/4 September 16, 2021. Supersedes Technical Service Bulletin Group 91 number 20-58 dated December 18, 2020 for reasons listed below.

Model(s)	Year	VIN Range	Vehicle-Specific Equipment
A4, A4 allroad, S4, A5, A5 Cabriolet, A5 sportback, S5, S5 Cabriolet, S5 sportback, Q5, SQ5, Q7, and SQ7	2018	All	connected gateway

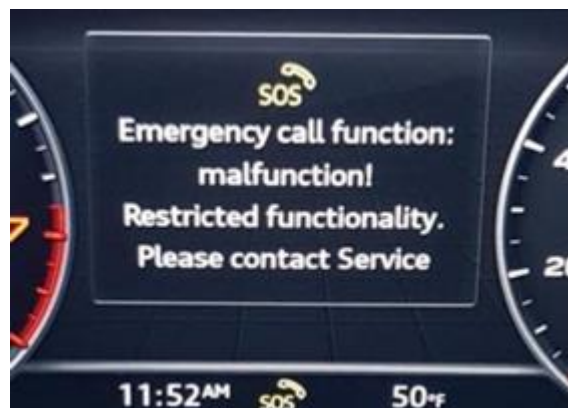
- The warning message “Emergency call function: malfunction! Restricted functionality. Please contact Service” appears in the instrument cluster (Figure 1).

Figure 1. The warning message is shown in the instrument cluster.

- **DTC B191604** (Backup battery Faulty).

Incorrect software parameter for the connected Gateway's back-up battery charge monitoring. The system must be reset by performing a manual discharge of the connected Gateway's backup battery.

1. Perform a manual discharge of the connected gateway's backup battery by removing constant power (KL30) and accessory power (KL15), while KL15 is switched on.

If the fault does not clear and is marked as active/static, then replace the connected gateway's backup battery. Consult the Elsa Repair Manual for instructions on replacing the connected gateway's backup battery. Consult the parts catalog for the correct part number of the connected gateway's backup battery.

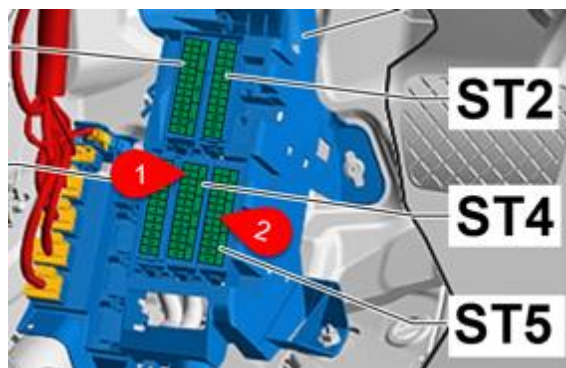
Figure 2. Q7 Driver's Side Footwell Fuse Box. 1: KL15 Fuse. 2: KL30 Fuse.

2. Gain access to fuse panel SB, located behind the driver's side footwell cover. Consult the Elsa Repair Manual for instructions on accessing fuse panel SB.

3. Locate the two fuses which supply constant power (KL30) and accessory power (KL15) to the connected gateway. Consult the wiring diagram or Owner's Manual for the fuse location and size.

4. Ensure that accessory power (KL15) is ON.
5. Remove the two fuses identified in Step 3.
6. Wait 30 seconds with both fuses removed.
7. Reinstall the two fuses.

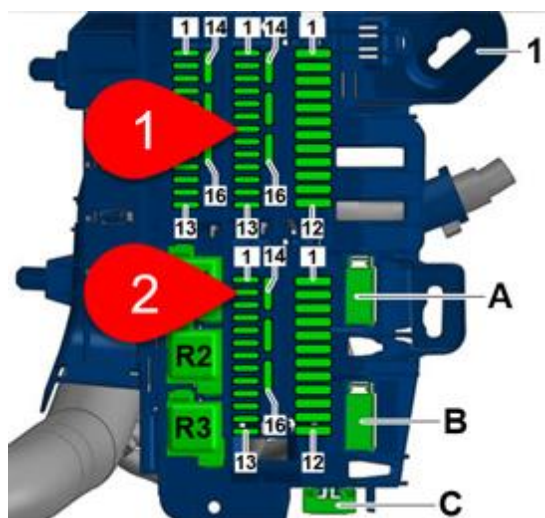
Figure 3. A4, A5, and Q5 Driver's Side Footwell Fuse Box. 1: KL30 Fuse. 2: KL15 Fuse.
